Office-Shop

Review conducted January 2012 using 2010 ADA Standards for Accessible Design.

Areas of Non-Compliance & Recommendations

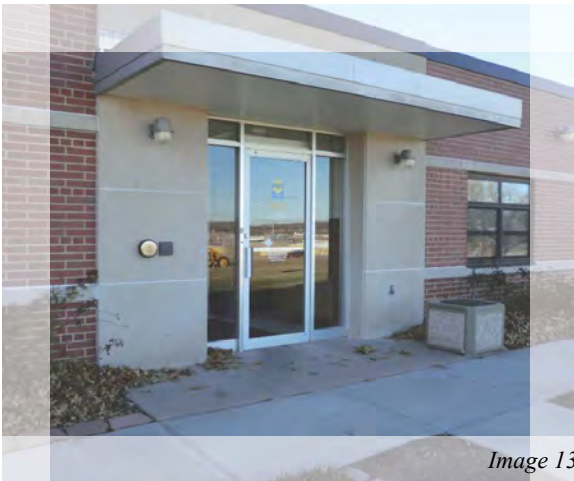
- 0-013 Inadequate maneuvering clearance at public entrance door due to change in level at transition between sidewalk and landing at door (58 inches). Maneuvering clearance of 60 inches perpendicular to the pull side of a door must be provided for a forward approach. [ADA Section 404.2.4.1] (See Image 13 on page 6).

» *Recommendation: Raise sidewalk at transition to landing or increase perpendicular size of landing for adequate clearance space.*

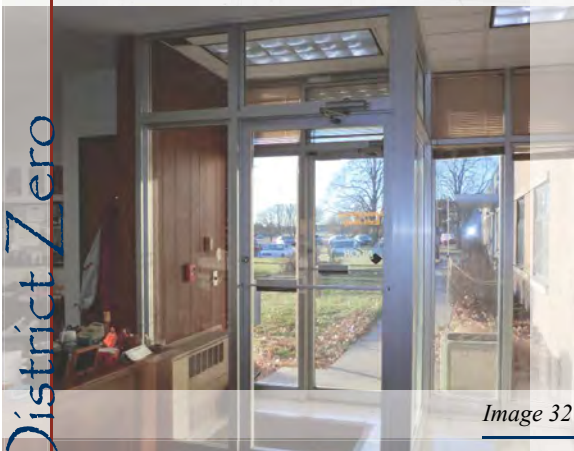
Image 32

- 0-033 Closing speed and opening force of doors in south exit vestibule (near reception area 123) greater than allowed by ADA Design Standards. Doors with closers must allow sufficient time for disabled users to safely enter and exit and require no more than 5 # force to push or pull open. (Fire doors are not required to meet ADA opening force guidelines but may be regulated by a local administrative authority). [ADA Sections 404.2.8 and 404.2.9] (See Image 32).
- » *Recommendation: Adjust door closers.*

- 0-034 Inadequate maneuvering clearance at interior door in south exit vestibule (near reception area 123). Maneuvering clearance 60 inches perpendicular to the door must be provided for a forward approach on pull side. [ADA Section 404.2.4] (See Image 32).

» *Recommendations: Lengthen vestibule.*

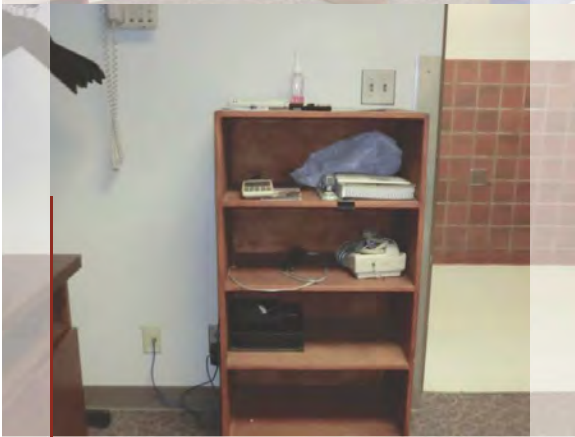
Image 36

- 0-038 Inadequate maneuvering clearance at entrance door due to placement of bookshelf (3 inches). Maneuvering clearance of 18 inches parallel to the pull side of a door must be provided for a forward approach. [ADA Section 404.2.4] (See Image 36).

- 0-039 Access to light switches obstructed by placement of bookshelf. Where a clear floor space requires an obstructed parallel approach to an element, the height of the obstruction shall be 34 inches maximum, and the high side reach shall be 46 inches maximum for a reach depth of 24 inches. Height of bookshelf is 45-1/4 inches and reach is 47-3/4 inches to centerline of light switch. [ADA Section 308] (See Image 36).

» *Recommendation: Relocate book shelf.*

» *Recommendation: Relocate bookshelf.*

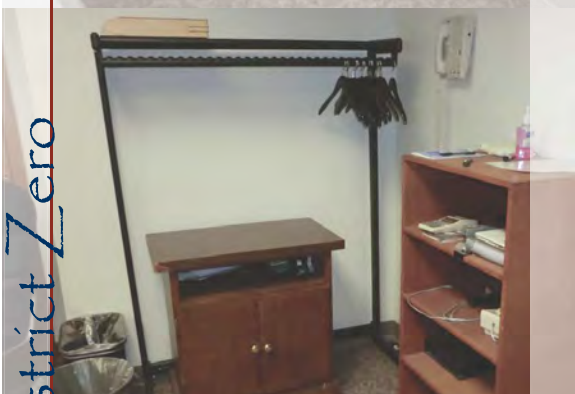
Image 38

- 0-041 Access to coat rack above allowed reach range (58-3/4 inches a.f.f. to rod/61-1/4 inches to shelf). Where coat storage is provided, restriction to use by people with disabilities is prohibited. [ADA Sections 225.2 and 811] (See Image 38.)

- » *Recommendations:*
Replace coat rack with one meeting ADA reach range requirements.

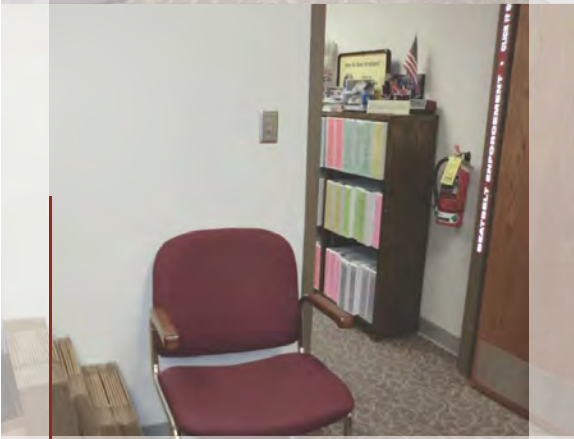
Image 52

- 0-054 Inadequate maneuvering clearance at entrance door to manager's office due to placement of chair (6 inches). Maneuvering clearance of 18 inches parallel to the pull side of a door must be provided for a forward approach. [ADA Section 404.2.4.3] (See Image 52).

» *Recommendation: Relocate chair.*

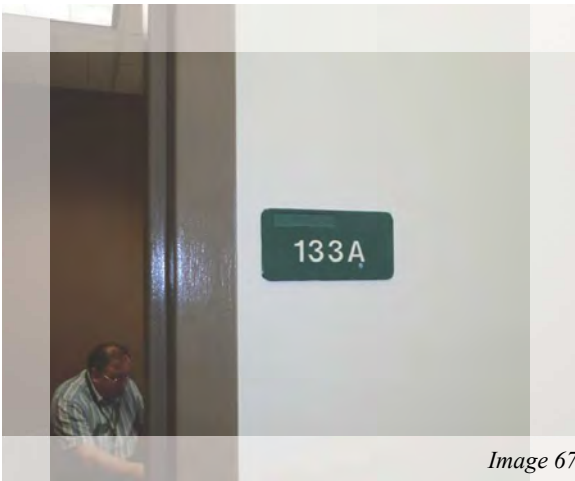
Image 67

- 0-069 Room identification sign for 133A mounted above allowed height with braille in wrong location (61-1/2 inches to baseline of room number). Tactile characters on signs shall be located between 48 inches and 60 inches above the finished floor measured from the baseline of the tactile characters. Braille shall be positioned below the corresponding text. [ADA Sections 216 and 703] (See Image 67).

» *Recommendation:*

Replace sign with one that has compliant positioning of braille tactile characters.

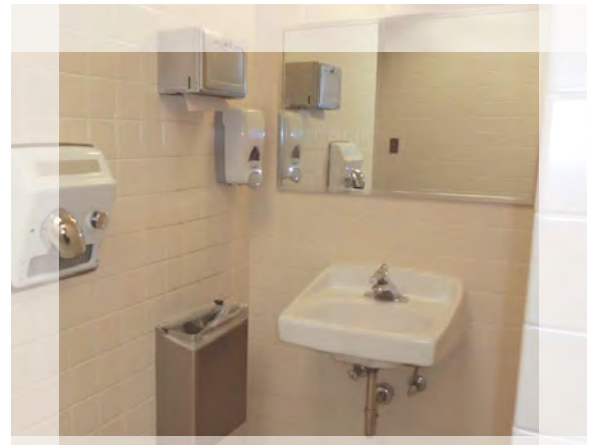
Image 101

- 0-124 No pipe protection provided under lavatory. Water supply and drain pipes under lavatories must be insulated or otherwise configured to protect against contact. [ADA Section 606.5] (See Image 101).

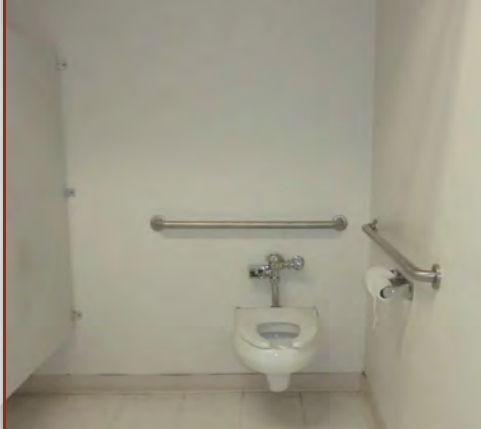
Image 107

- 0-136 Toilet seat above allowed height (19-1/2 inches a.f.f.). The seat height of a water closet shall be 17 inches minimum and 19 inches maximum above the finished floor measured to the top of the seat. [ADA Section 604.4] (See Image 107).

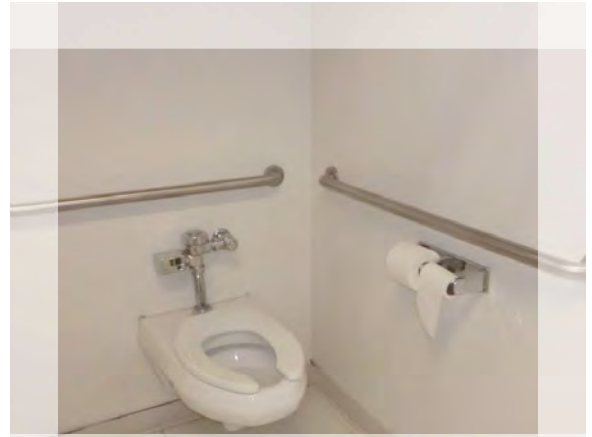
Image 109

- 0-138 Grab bars mounted too high above finished floor (36-1/2 inches a.f.f. - rear/ 36-3/4 inches a.f.f. - side). [ADA Section 609.4] (See Image 109).

- 0-139 Side wall grab bar does not extend 54 inches from the rear wall (48 inches). The side wall grab bar shall be located 12 inches maximum and extend 54 inches minimum from the rear wall. [ADA Section 604.5.1] (See Image 109).

» *Recommendation: Reinstall grab bars so that tops of gripping surfaces are between 33 and 36 inches above finished floor.*

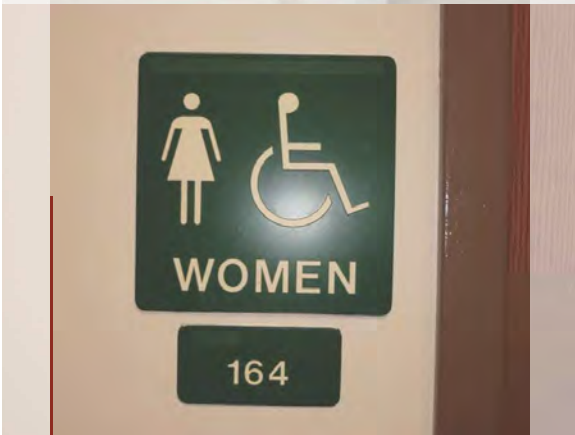
Image 114

- 0-146 Braille on restroom identification sign placed in wrong location. Braille shall be positioned below the corresponding text. [ADA Section 703.3.2] (See Image 114). ⚓

» *Recommendation: Replace sign with one that has compliant positioning of braille tactile characters.*
Cost Estimate: \$100.00

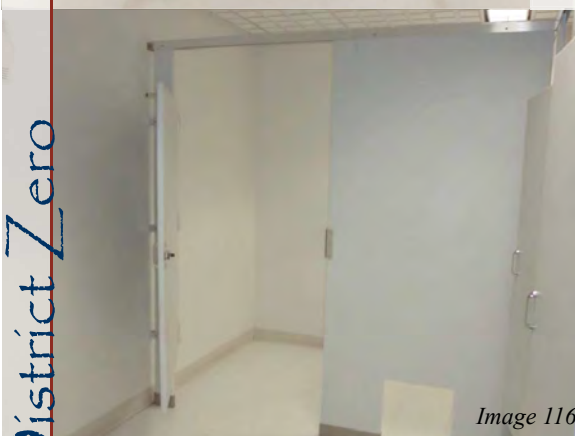
Image 116

- 0-149 Door to toilet compartment not self-closing. [ADA Section 604.8.1.2] (See Image 116). ⚓

» *Recommendation: Install self-closing door.*

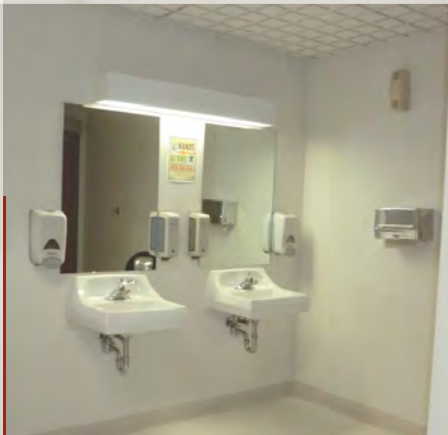
Image 122

- 0-156 No pipe protection provided under lavatory. Water supply and drain pipes under lavatories must be insulated or otherwise configured to protect against contact. [ADA Section 606.5] (See Image 122).

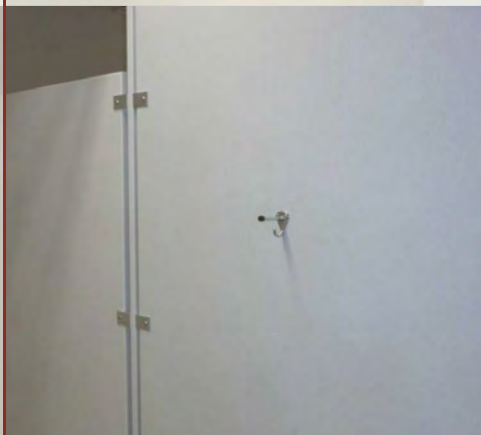
Image 123

- 0-158 Coat hook on wall of toilet compartment above allowed reach range (54-1/4 inches a.f.f.). [ADA Sections 308 and 604.8.3] (See Image 123). ⚓

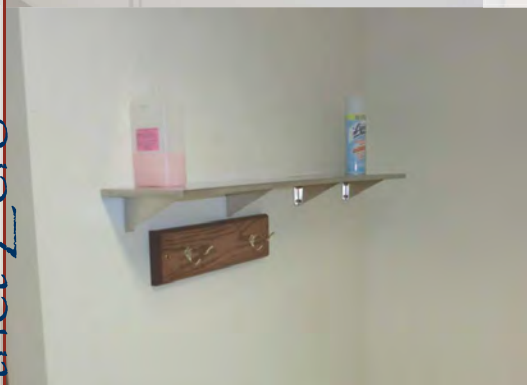
Image 124

- 0-159 Shelf mounted above allowed height and creates protrusion (54 inches a.f.f.). Shelves shall be located 40 inches minimum and 48 inches maximum above the finished floor. Objects with leading edges more than 27 inches and not more than 80 inches above the finished floor shall not protrude more than 4 inches horizontally within the clear floor space. When a cane is used and the element is not in the detectable range, insufficient time is available for the person to detect the element with the cane before there is body contact. [ADA Sections 307.2 and 603.4] (See Image 124). ⚓ for shelf mounting height
